**INTERNATIONAL ROAD DYNAMICS INC.**

- Site Service Report -**Date:** February 15, 2011**From:** Rino Quiñones**Project Name/Location:** I-95 Maine, mile marker 200.2 North Bound**Service Date(s):** February 15th 2011**IRD Contract No.:** 11167**To:** Cindy Mantie**Job Description:** Service Visit Due to Kistler Sensors not working. Implement Field Change Order 15401601.**Work Completed:**

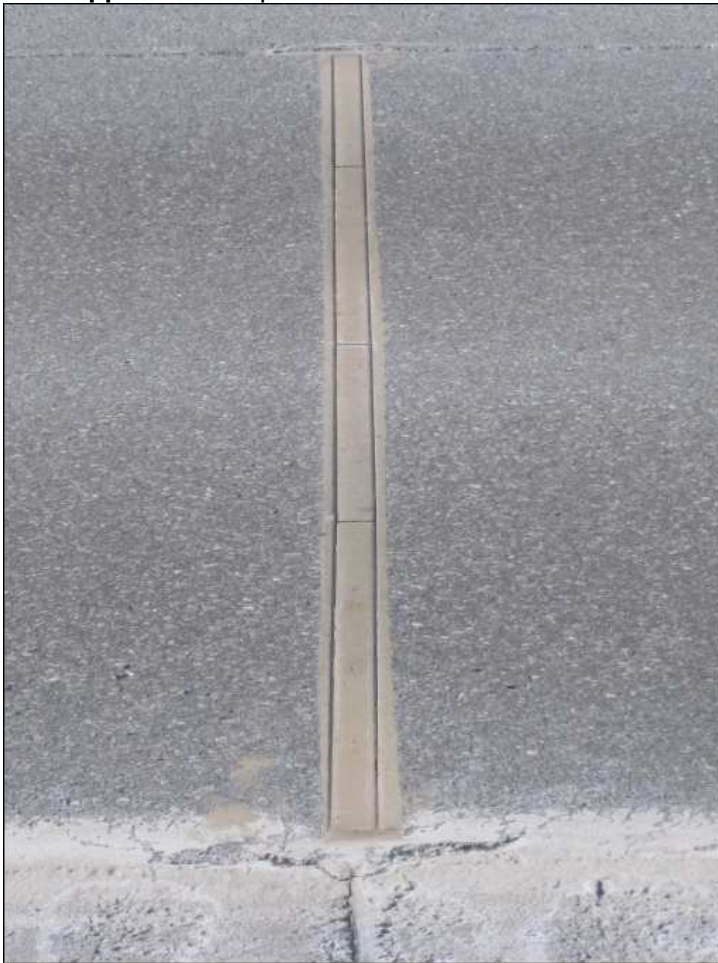
Appendix A: Upstream Kistlers 1 to 4

- 7) Tested batteries, 14Volts.
- 8) Called Jason Penney to check on remote connection to site; good. Jason to download data tomorrow and check.
- 9) Took pictures of site. Noticed cracks on the white line right by the Kistler sensors.

Item	Action Required	Ownership
1.	Kistler sensors failing due to low insulation resistance. Determine course of action as per contract requirements. Note cracks on the pavement, see pictures on Appendix A.	Cindy M.
2.		
3.		
4.

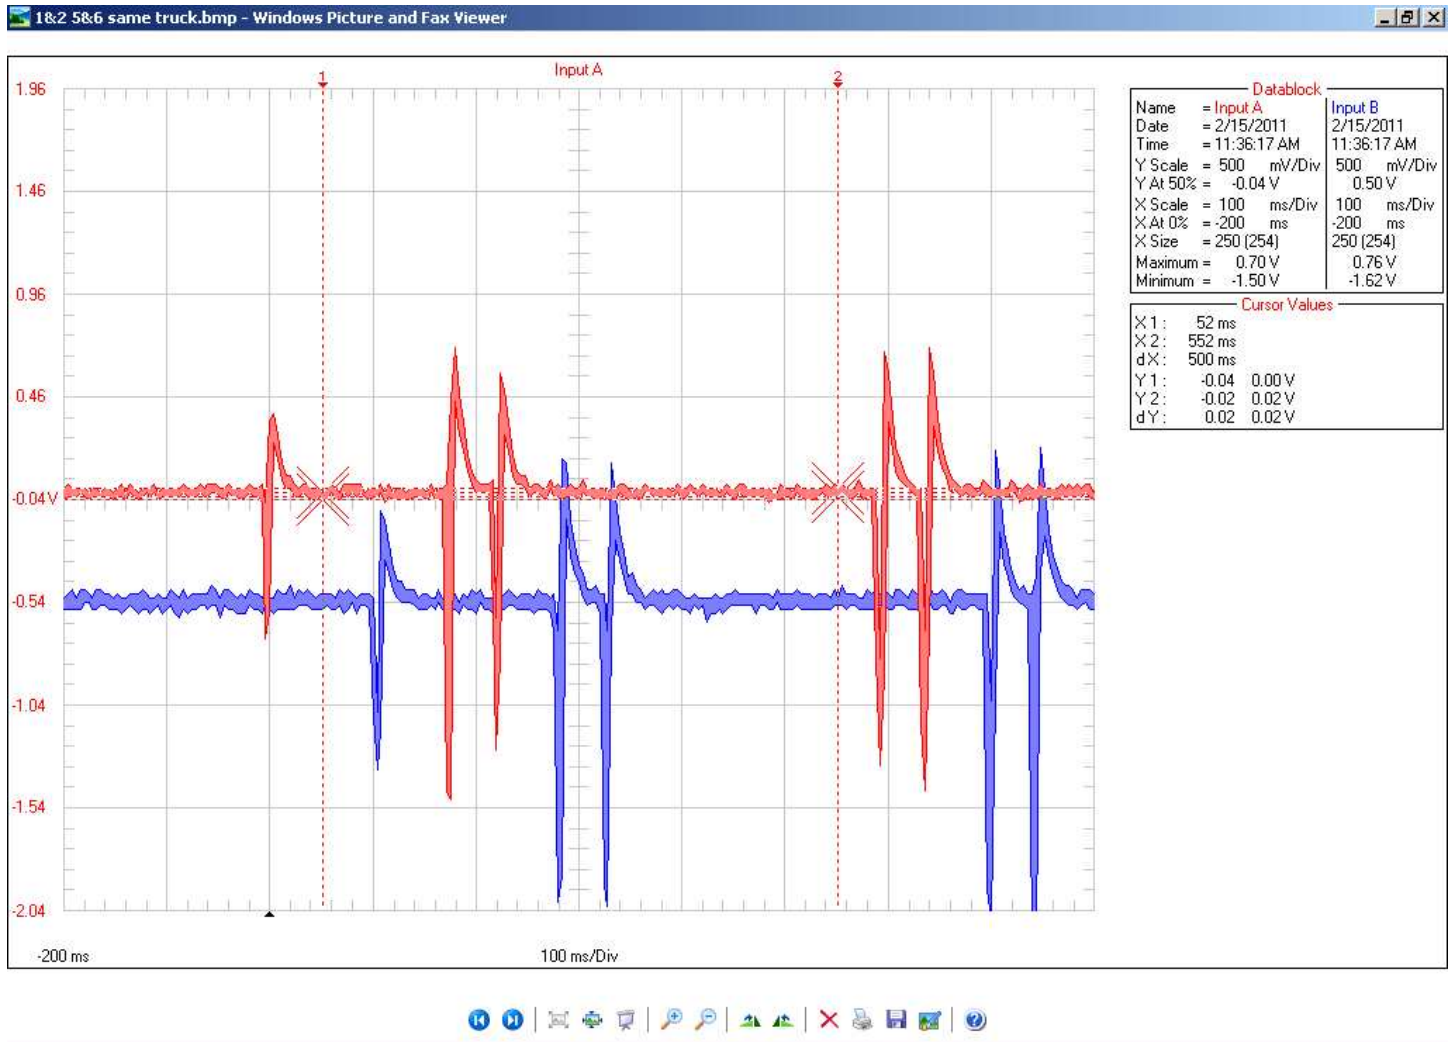
Noticed problem on pair K1 and K2 pair. Scope trace signal is intermittent. K5 and K6 pair signals are good. K5 and K6 are on the same side of the road as K1 and K2. Any axles going over K5 and K6 must also be going over K1 and K2. K1 waveforms okay. K2 waveforms are not causing trigger on the scope although I was able to see waveforms momentarily. Re-terminated cable of K2, results are good.

Appendix B: Kistlers 1&2 (red), and 5&6 (blue) oscilloscope traces. These are good signals.

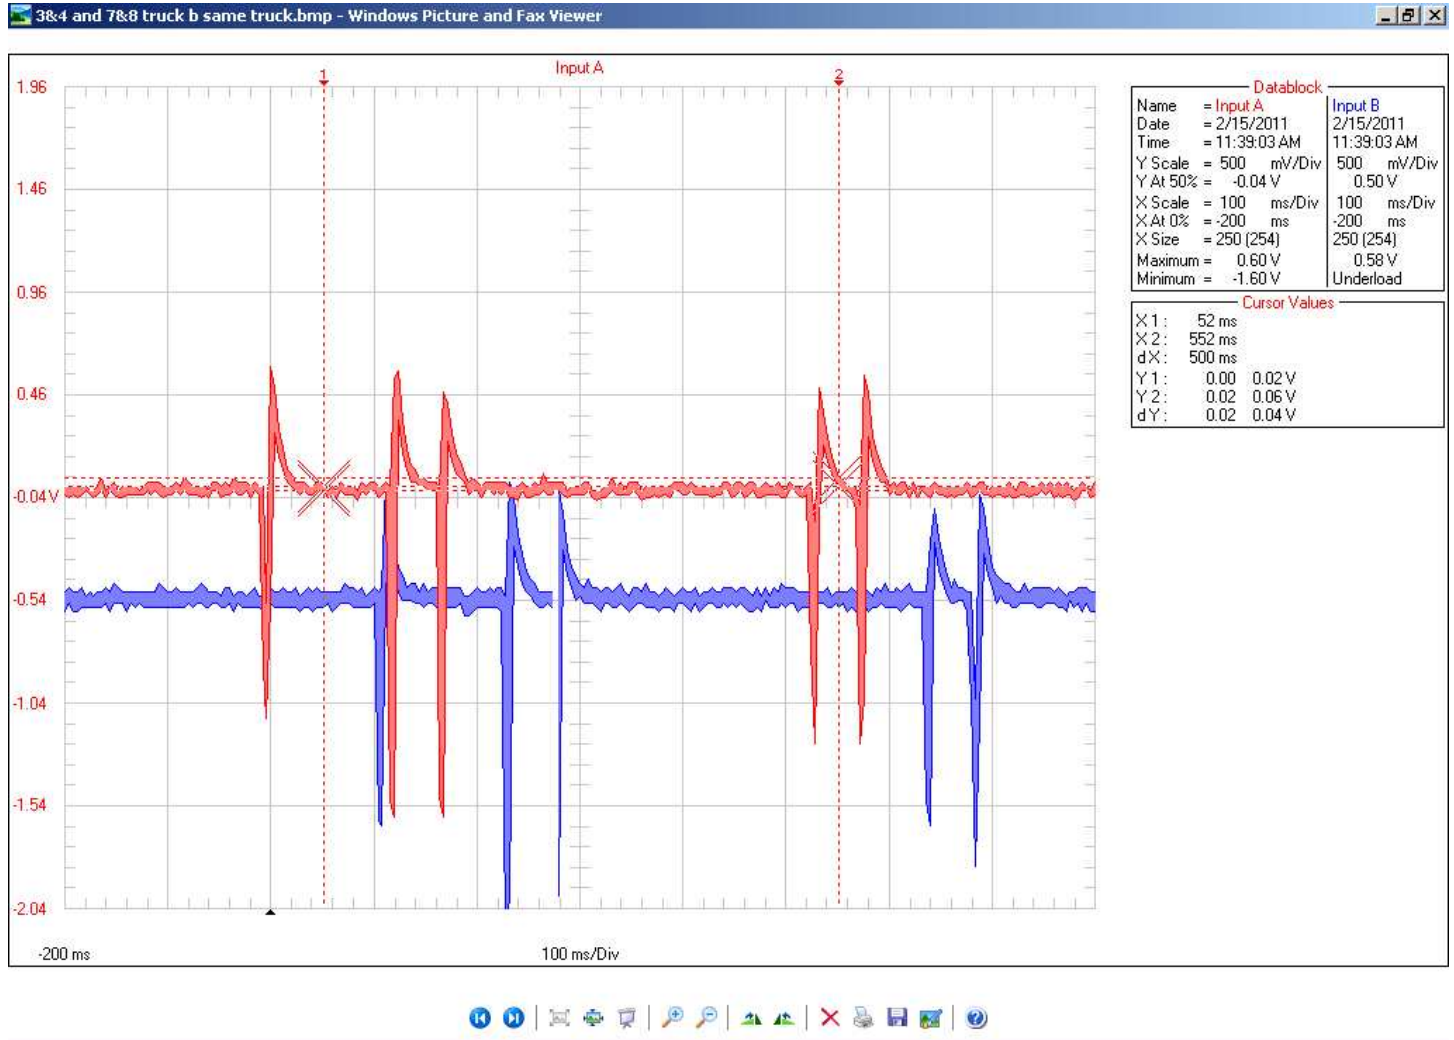
Appendix B: Continued....Kistlers 3&4 (red), and 7&8 (blue) oscilloscope traces. These are good signals.

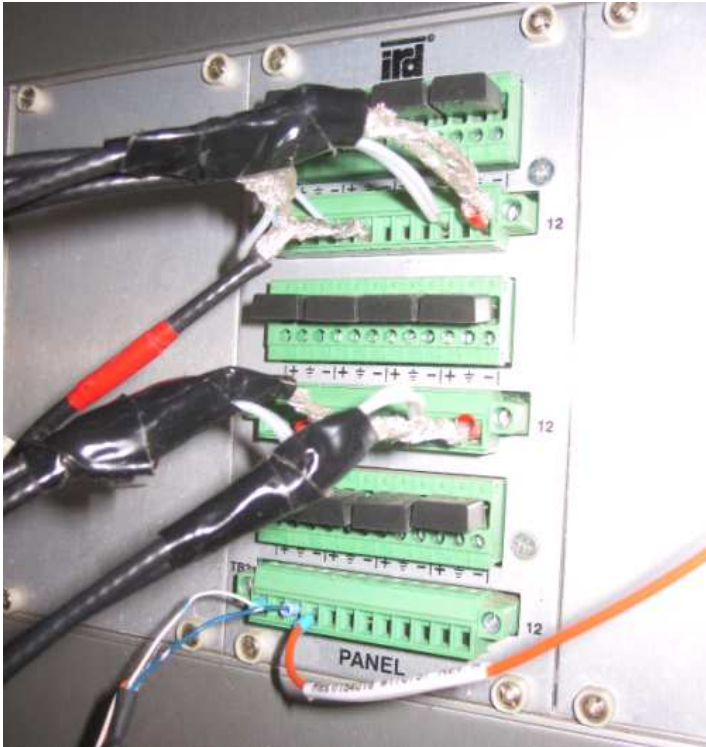
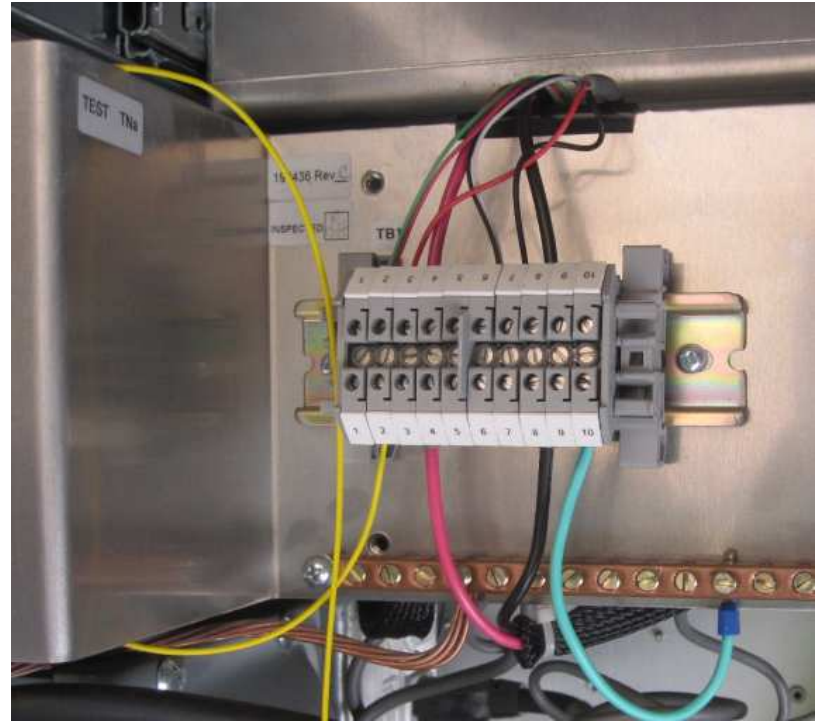
Kister Sensors and Temp Sensor Termination

Pull-up resistor yellow wire connection to +12Vdc

- 1) Hazard Assessment completed. Enough room in the shoulder to park, and with proper gear to work in cold weather.
- 2) Installed Pull-up resistor for the temperature sensor as per Field Change Order 15401601. This change is required for temperature sensors with lead cable length of 300ft or shorter lengths having problem.
- 3) Tested sensors prior to removal of the solder sleeves on the Kistler sensors. See tables 1, 2 and 3.
- 4) Tested lighting protection tabs on the SIOP. All are OL's (good).
- 5) Removed solder sleeves on all Kistler sensors. Tested Kistler Sensors using DVM, LCR, Insulation Tester, and dual trace oscilloscope.

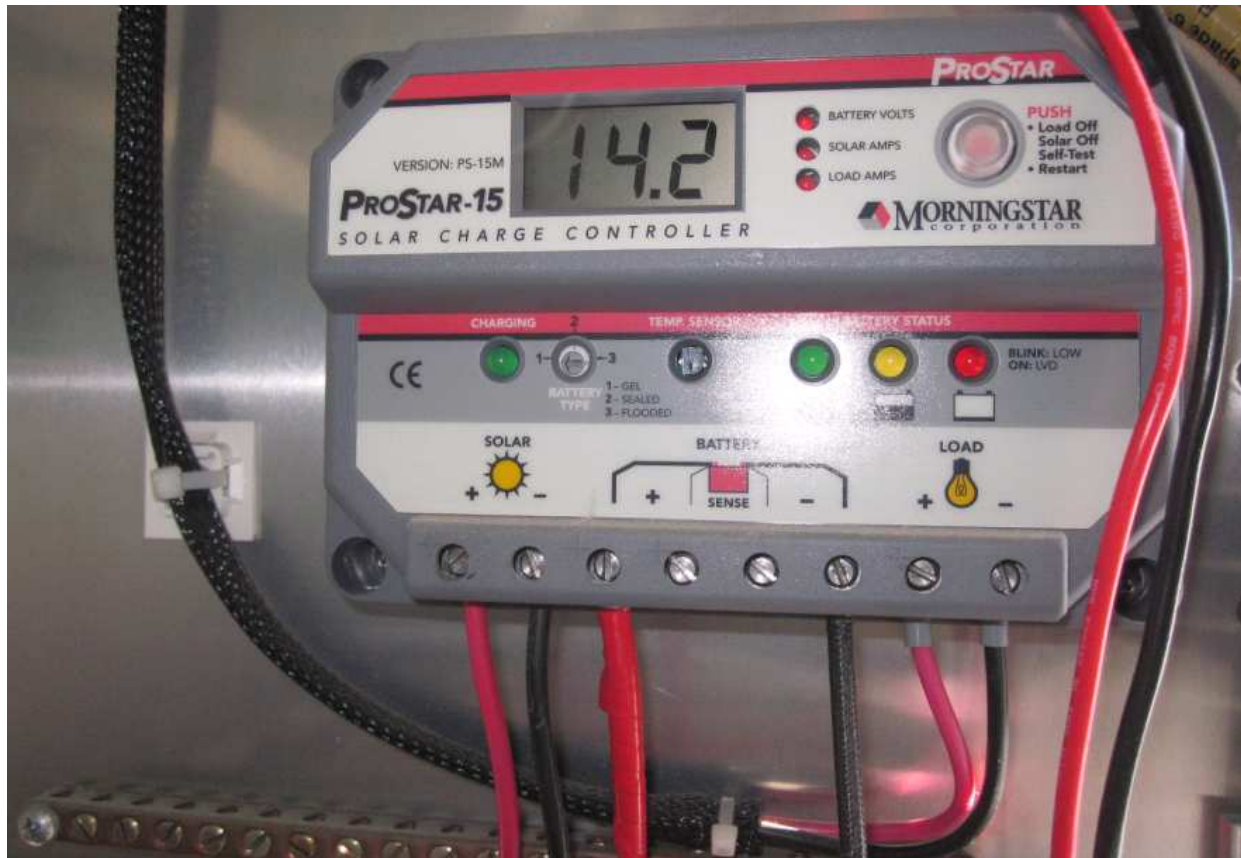
Charger showing 14.2Volts of batteries
